Manhole Inspection Summary

Manhole # S41C__046MH

Insp Date: **6/27/08 2:30 PM**

Location Address: **106 n central ave**

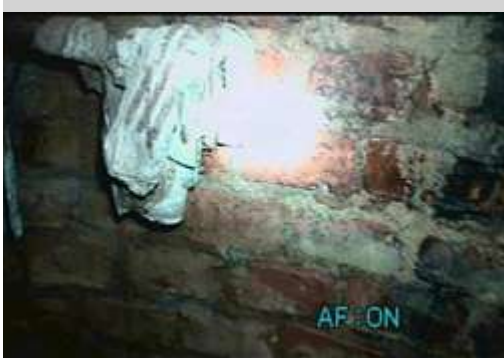
Defect 4

☒ **Evidence Of Surcharge** Depth: **7.** (ft.) ☐ Active Surcharge Present

surcharge evidence

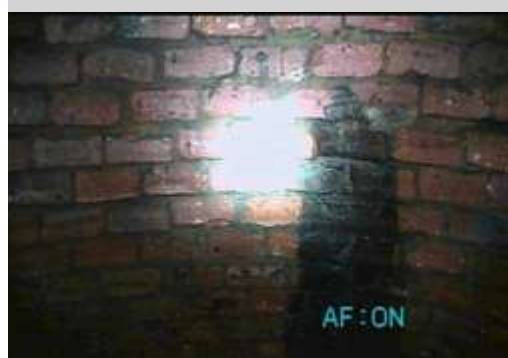
Defect 3

Infiltration: ☐ None ☐ Joint ☐ Cracks ☒ **Mortar** ☐ Roots ☐ Wall

infiltration in barrel mortar

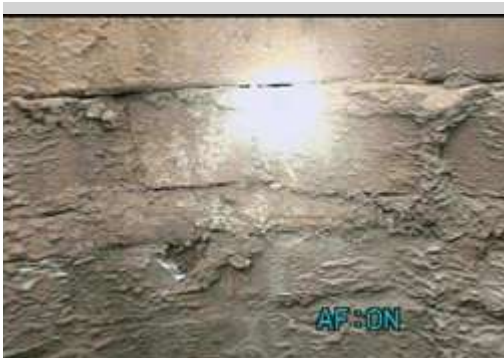
Defect 2

Infiltration: ☐ None ☒ **Joint** ☐ Cracks ☐ Mortar ☐ Roots ☐ Wall

chimney infiltration at joint

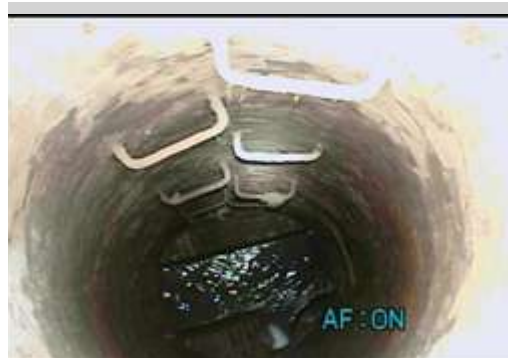
Defect 1

Count: **9** Missing: **0** ☒ **Corroded**

steps

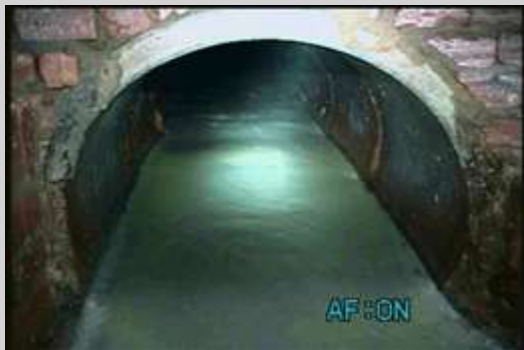
12 O'Clock Outflow

24 in. Circular Gravity Sewer
Pipe Out @ 12 O'Clock

Pipe Material: **Clay** ☐ Pipe Lined

Invert Depth: **15.88** (ft.) Flow Characteristics: **Fast**

Infiltration: **None** Pipe Seal Cond: **Unknown**

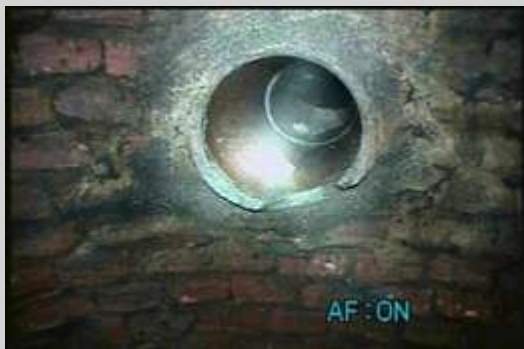
3 O'Clock Inflow

8 in. Circular Gravity Sewer
Pipe In @ 3 O'Clock

Pipe Material: **Clay** ☐ Pipe Lined

Invert Depth: **9.57** (ft.) Flow Characteristics: **Fast**

Infiltration: **None** Pipe Seal Cond: **Unknown**

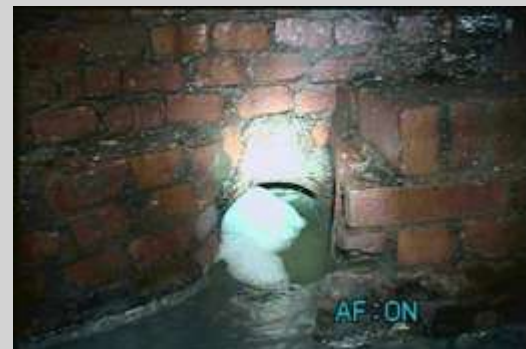
Drop In @ 3 O'Clock

Drop: **Outside Direct**

Inv Depth: **15.71** (ft.)

Drop Condition: **Open**

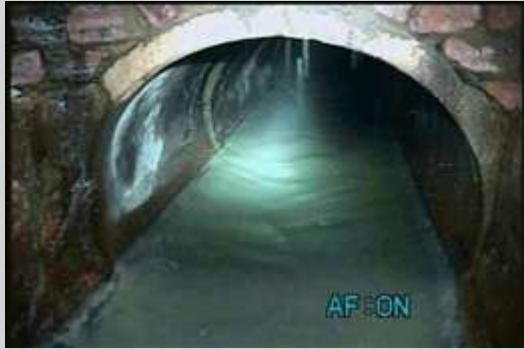
6 O'Clock Inflow

24 in. Circular Gravity Sewer
Pipe In @ 6 O'Clock

Pipe Material: **Clay** ☐ Pipe Lined

Invert Depth: **15.52** (ft.) Flow Characteristics: **Fast**

Infiltration: **None** Pipe Seal Cond: **Unknown**
